## Site Inspection Report Summary

**Property Address:** 6231 PA-88 Finleyville, PA 15332

**Inspection Date:** 06/10/2020

## **Photo Report of Koteles Garage**

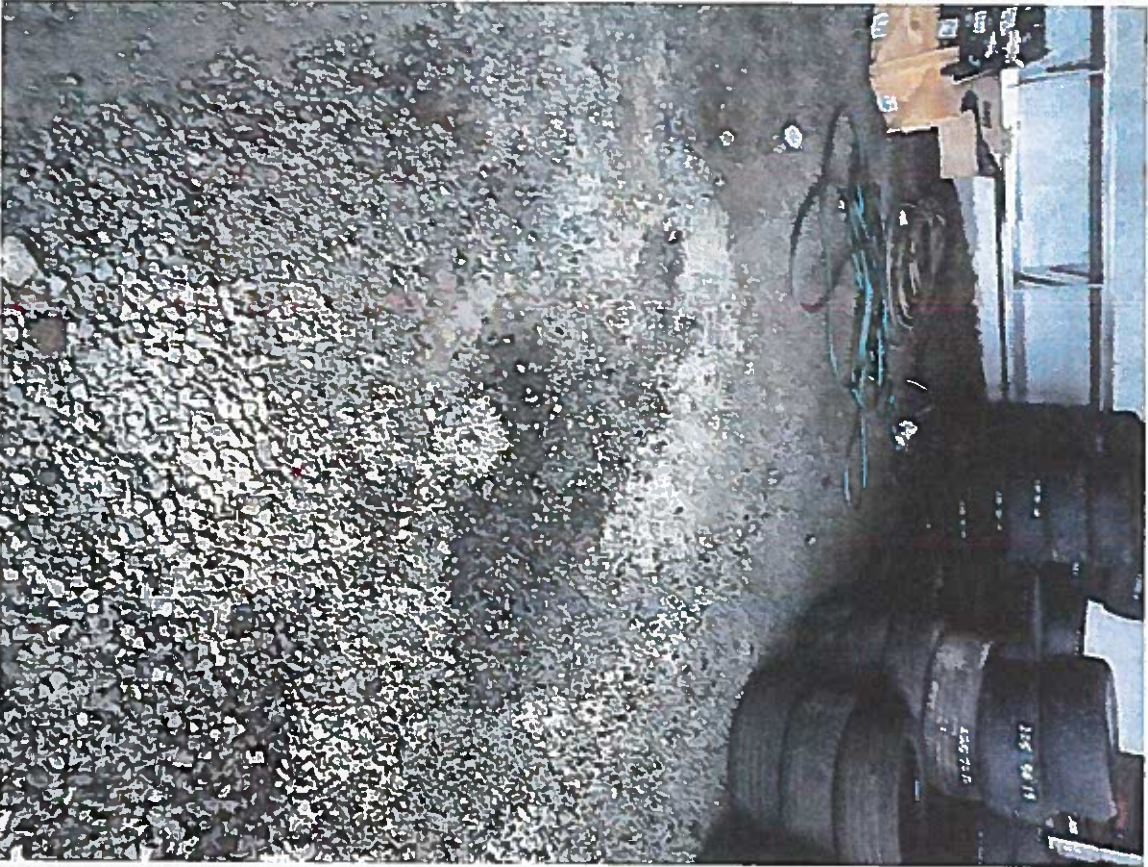
Oil spill on gravel in rear garage.

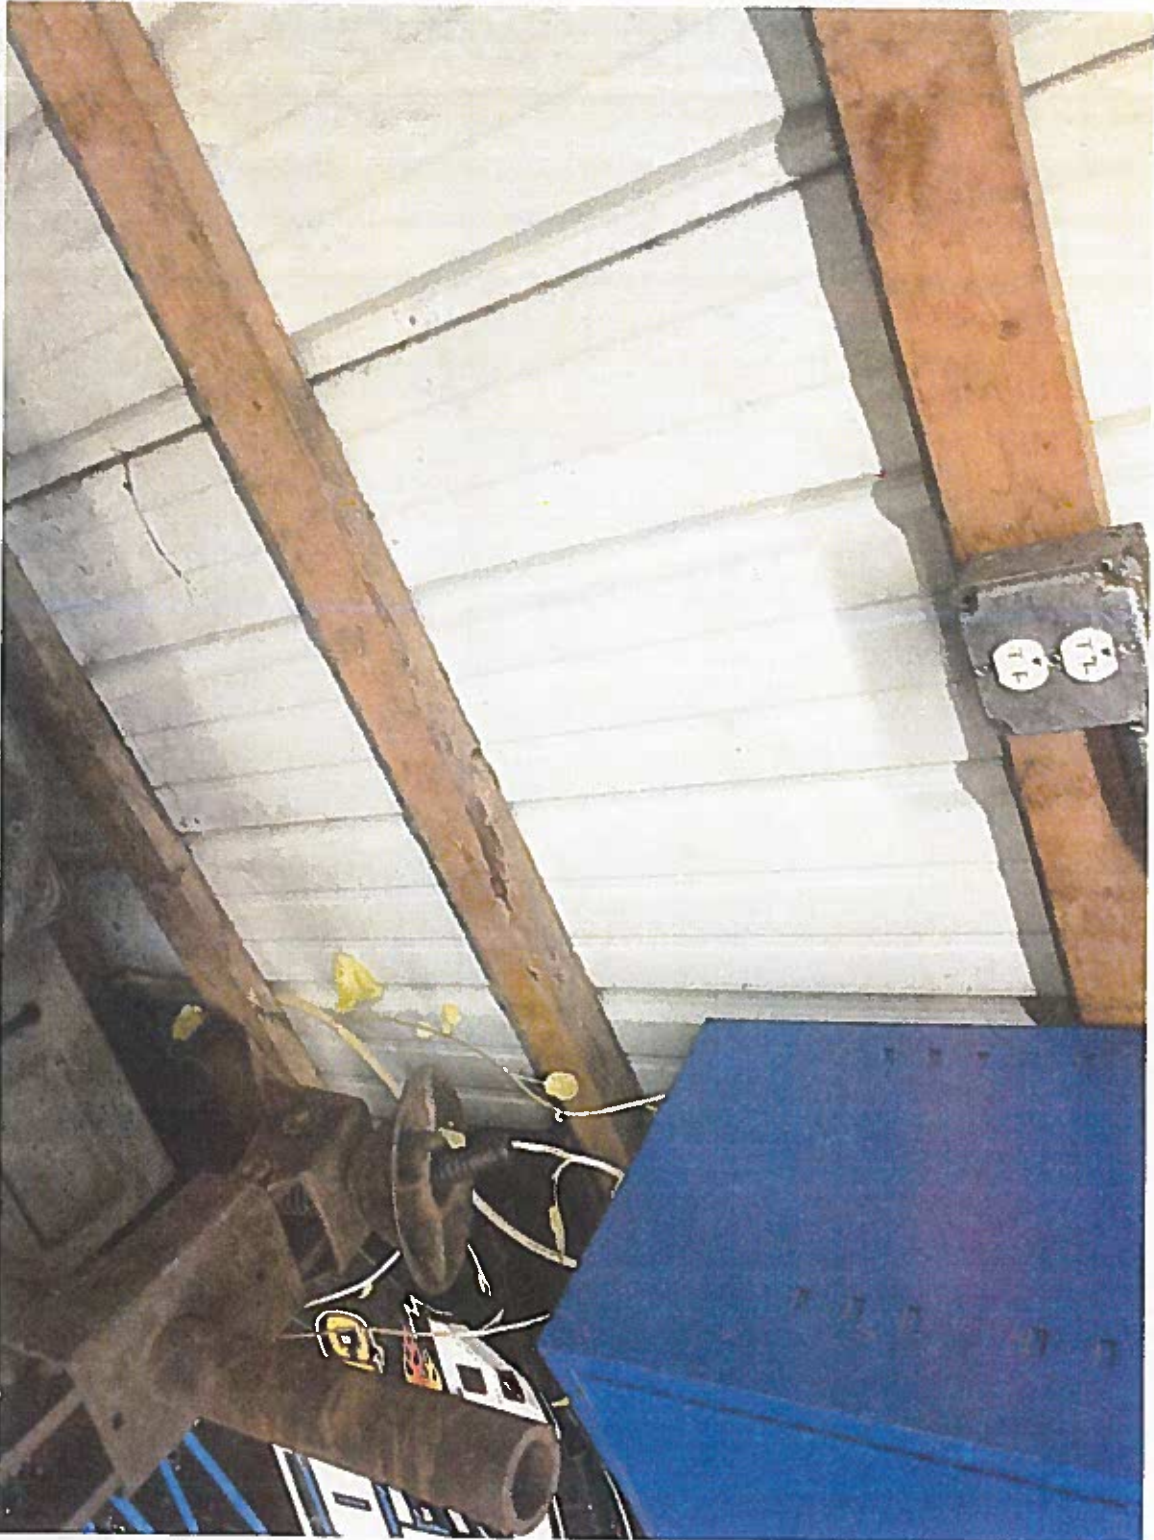
Plant from the outside is growing into the rear storage building.

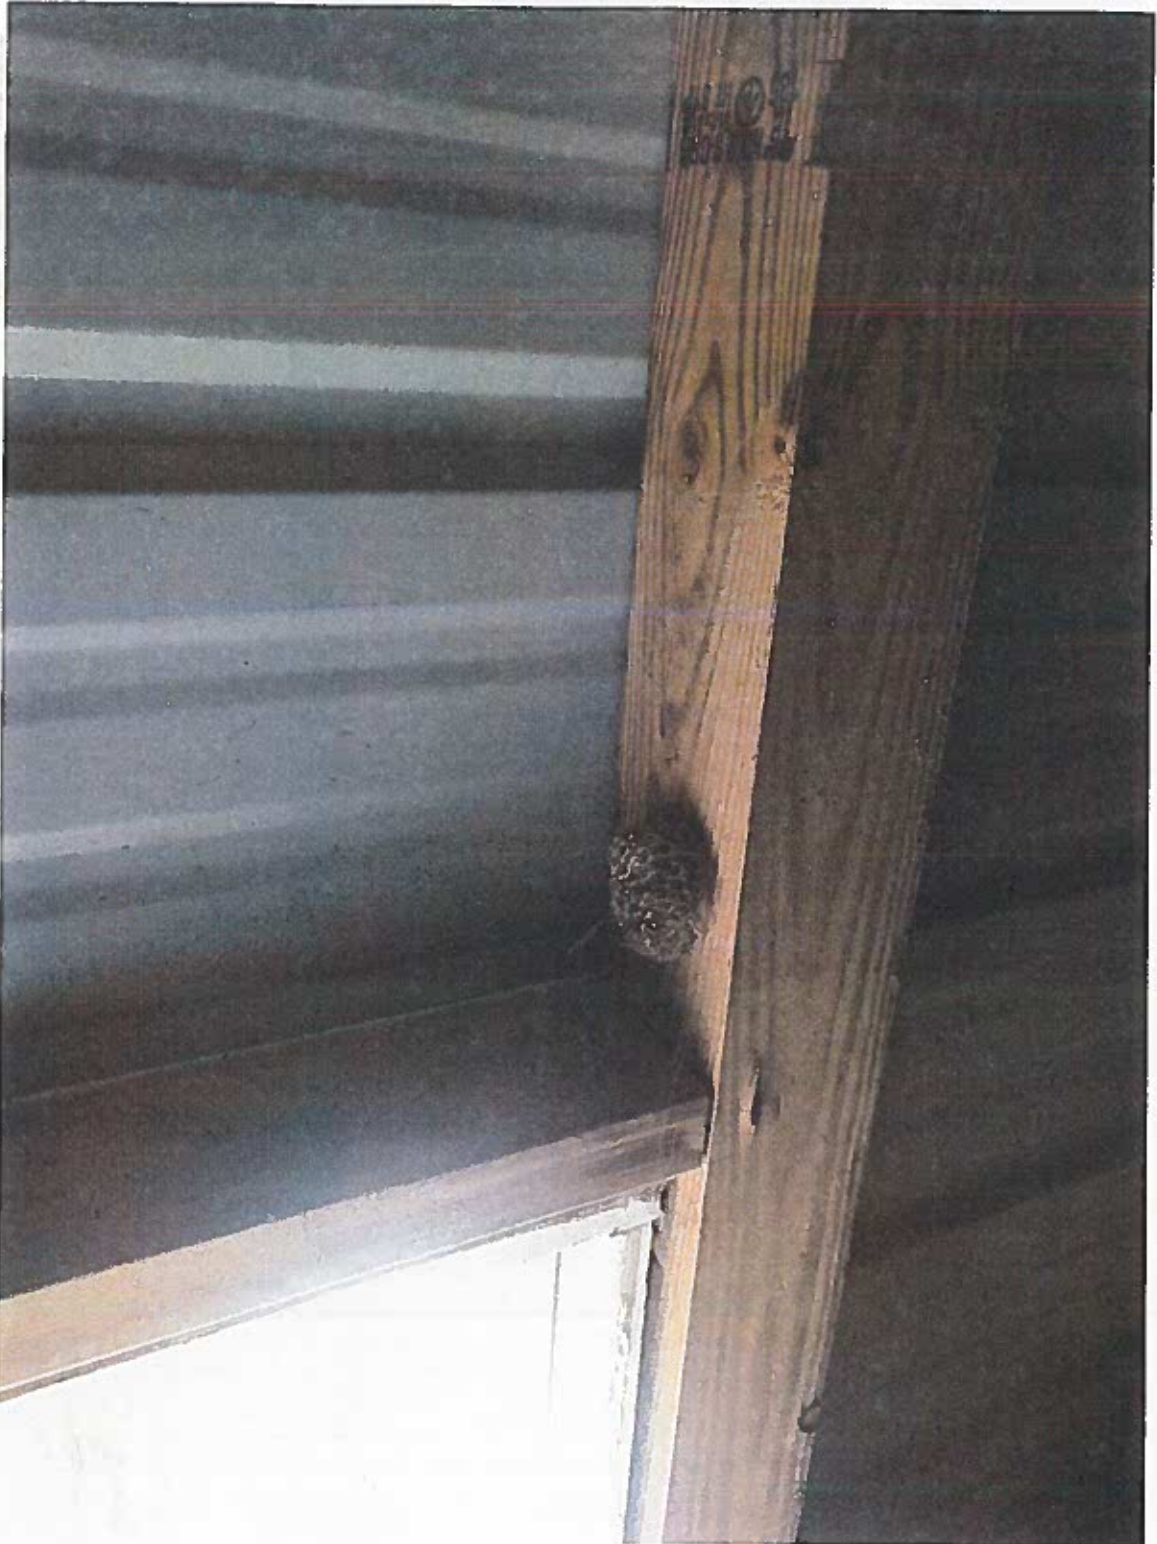
A wasp nest was found adjacent to the inside of the door to access the rear storage area.

Wasp nest near rear entry door.
